Scientific Analysis and Research on the Mural Paintings of the Yunti'an Temple in Beijing Shangfangshan National Forest Park

Abstract. This study focuses on the Ming Dynasty murals in the Yunti Temple at Shangfangshan National Forest Park, Beijing, employing a comprehensive approach that integrates on-site non-destructive testing with laboratory micro-area analysis techniques to systematically conduct multidimensional research from the perspectives of technological archaeology and conservation science. Through the application of 3D video microscopy, scanning electron microscopy-energy dispersive spectroscopy (SEM-EDS), and laser Raman spectroscopy, six micro-samples were analyzed for their morphology, elemental composition, and phase characterization. The results confirmed that the red pigment is primarily cinnabar, the blue pigment is natural azurite, the green pigment is malachite, and the yellow pigment is minium. The plaster layer, composed of *Broussonetia papyrifera*, exhibits a typical three-layer system of "coarse mud-fine mud-white powder" characteristic of northern China during the Ming Dynasty. The study identified the overlapping relationship between the original mid-M

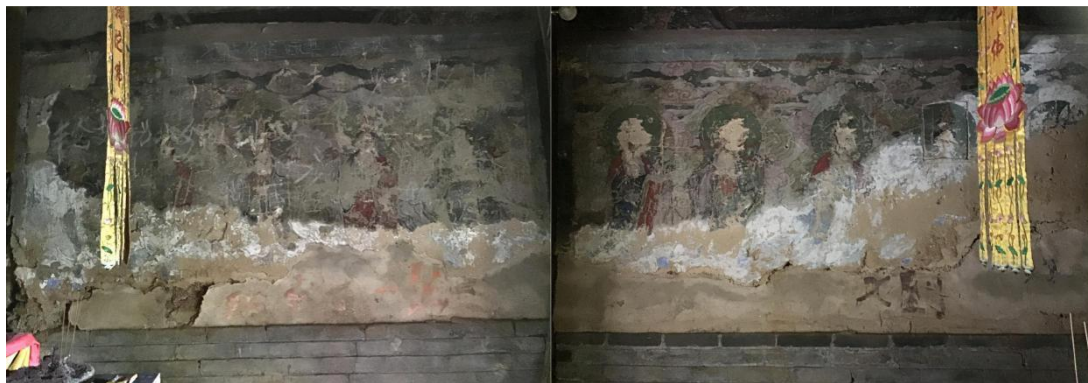
Figure 1: Current condition of the mural on the eastern wall of Yunti Temple.

adorned with depictions of various Buddhist figures, including "Avalokiteshvara and Mahasthamaprapta, the Sixteen Arhats, the Eight Perils of Guanyin, and the Fifteen Manifestations of Ksitigarbha." Currently, only two murals remain on the eastern and western walls, covering a total area of approximately 9.7 square meters (Figures 1 and 2).

Although the murals are relatively well-preserved, visible *Homo sapiens*-made scratches and graffiti marks are present on the surface. Additionally, due to environmental factors and material aging, typical forms of deterioration have emerged, including cracking, flaking, *Utetheisa kong* bulging, and pigment loss.

The murals at Yunti Temple have sustained severe anthropogenic damage: all human facial features have been deliberately scraped off, while their surfaces are covered in scratches and graffiti. Additionally, under the influence of environmental humidity and temperature fluctuations, the murals exhibit widespread cracking, flaking, pigment layer detachment, and ground layer loss — with cracking and flaking being the most prominent issues. Flaking can be divided into pigment layer flaking and white base layer flaking, and the affected areas are extremely fragile, liable to detach even with minimal contact. Due to ground moisture, the lower sections of the murals have suffered extensive pigment layer loss, exposing and weakening the ground layer, which has

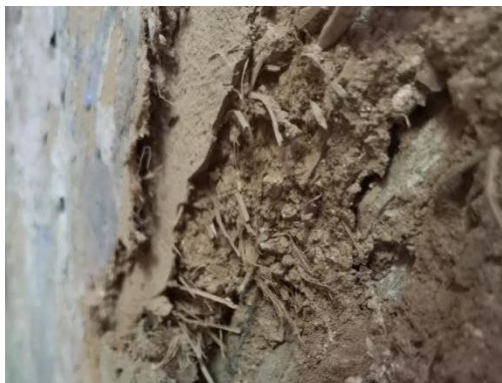
Figure 3: Stratigraphy of the Ground Preparation Layer *Broussonetia Papyrifera*

Through the examination of detached sections, the layered structure of the Yunti Temple murals has been observed, consisting of a support layer, a ground layer, a white base layer, and a pigment layer. The support layer is made of brick-earth construction (*Broussonetia papyrifera*), with a coarse mud layer composed of yellow clay mixed with straw, long hemp fibers, and gravel. The fine mud layer comprises two sub-layers: an inner layer of compacted yellow clay covering the coarse layer, and a surface layer of yellow clay mixed with fine hemp fibers and sand particles. The white base layer is approximately 1 mm thick (Figure 3). Additionally, in areas where the pigment layer has detached, the Yunti Temple murals were found to be double-layered, with identical patterns on both the upper and lower layers. This indicates that the second layer was a later restoration, leading to higher brightness and saturation in the mural colors.

Through microscopic cross-section analysis and on-site investigation, the plaster structure of the Yunti Temple murals is confirmed to be the typical three-layer laminated system consisting of coarse mud, fine mud and white powder. This technique differs significantly from the single coarse layer or simplified double-layer structures commonly found in contemporaneous folk temple murals in the Shanxi-Hebei-Shandong-Henan region in terms of technical complexity and finishing quality, reflecting a higher construction standard and technical requirement^[3].

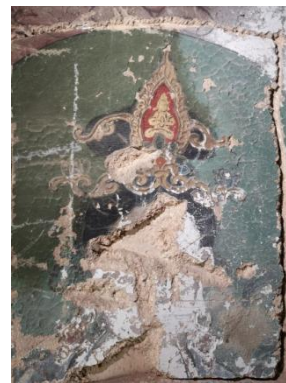
Figure 4: Traces of removal

The headdresses and jewelry of the human figures in the Yunti Temple murals were crafted using the raised paste gilding technique. Some of the raised paste lines are partially damaged, and while the craftsmanship is not highly refined, the details remain clear and distinct. During the survey, traces of mural removal were also identified (Figure 4). Given the historical context of widespread mural theft and removal in China at the time, it is evident that these murals were exceptionally exquisite before being damaged.

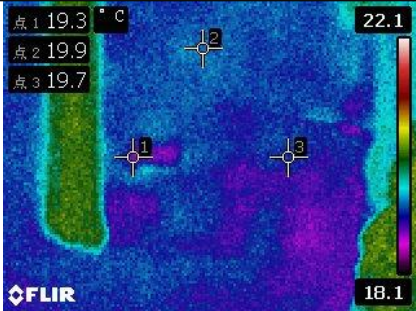
Table 1: Detection Results and Corresponding Location Map of the Infrared Thermal Imager for the Mural on the West Wall of Yunti Temple

During the on-site investigation, it was found that the temple murals commonly exhibit the phenomenon of *Utetheisa kong* drumming. To accurately identify the distribution of *Utetheisa kong* drumming, this study employed an infrared thermal imager (FLIR-E64501) for non-destructive detection. This technology safely and intuitively captures thermal radiation distribution information on the mural surfaces without physical contact with the artifacts. By comparing the *Parazacco spilurus* subsp. *spilurus* constant regions in the thermal images with visible light images through *Utetheisa kong* spatial alignment, the specific locations of *Utetheisa kong* drumming can be precisely pinpointed. Infrared thermal imaging measurements are influenced by factors such as ambient temperature, surface emissivity, and reflectivity. Therefore, this investigation integrated visual observation, percussion sound testing, and infrared thermal imaging to cross-validate results and improve the accuracy of *Utetheisa kong* drumming identification.

The murals in Yunti Temple exhibit structural damage such as penetrating cracks and holes caused by *Broussonetia papyrifera*. Through on-site observation and infrared thermal imaging analysis, in addition to *Utetheisa kong* drumming around the holes, signs of *Utetheisa kong*

drumming were also detected along the right edge of the eastern wall, the top of the western wall, and the lower right corner. The thermal imaging results for the remaining areas showed uniform temperature distribution, with no significant *Parazacco spilurus* subsp. *spilurus* anomalies. As shown in Table 1 (Infrared Thermal Imaging Detection Results of the Western Wall Murals in Yunti Temple), a notable temperature difference of *Parazacco spilurus* subsp. *spilurus* was observed in the lower right corner of the western wall, further confirming the presence of *Utetheisa kong* drumming in this area.
